Mitigation of Active Corrosion Fatigue and Corrosion Pit Initiated Fatigue in AA7075-T6 with Low Plasticity Burnishing

Paul S. Prev  y and N. Jayaraman
Lambda Research

John T. Cammett
NAVAIR

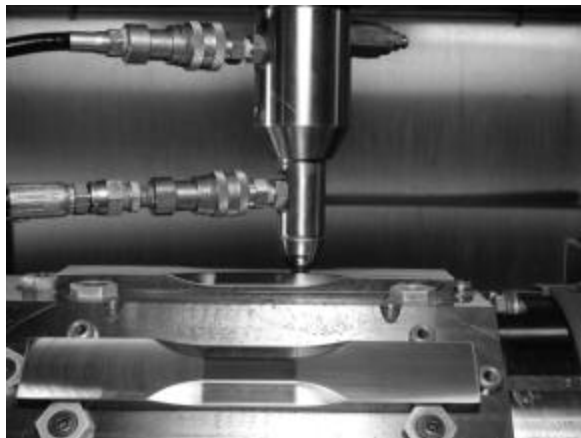
Figure 1 – LPB processing of fatigue samples with at single point contact LPB tool in a 4-axis CNC mill.

Using CNC positioning, the tool path is controlled so that the surface is covered with a series of passes at a separation maintained to achieve maximum compression with minimum cold working. The tool may be moved in any direction along the surface of a complex work piece, as in a typical multi-axis CNC machining operation. The LPB processing of fatigue specimens used in this investigation is depicted in Figure 1.

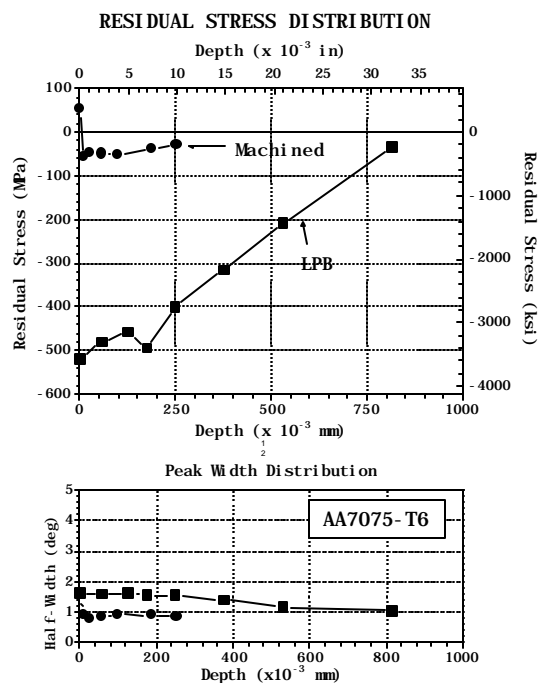
Figure 2 - Residual stress and half width distribution in machined and LPB processed AA7075-T6.

The residual stress distributions developed by machining and LPB processing of 7075-T6 are shown in Figure 2. Machining of 7075-T6 produced low tension on the surface and compression of less than -68 MPa (-10 ksi) below the surface. In contrast, LPB produced maximum compression on the order of -480 MPa (-70 ksi) between the surface and a depth of nominally 0.2 mm (0.008 in.). Maximum cold work occurs from the surface through the region of maximum compression, and then diminishes with depth. X-ray diffraction measurement could not be made reliably below a depth of 0.5 mm (0.02 in.) in the 7075-T6 because of the coarse grain size encountered at depths beneath the deformed surface layer.

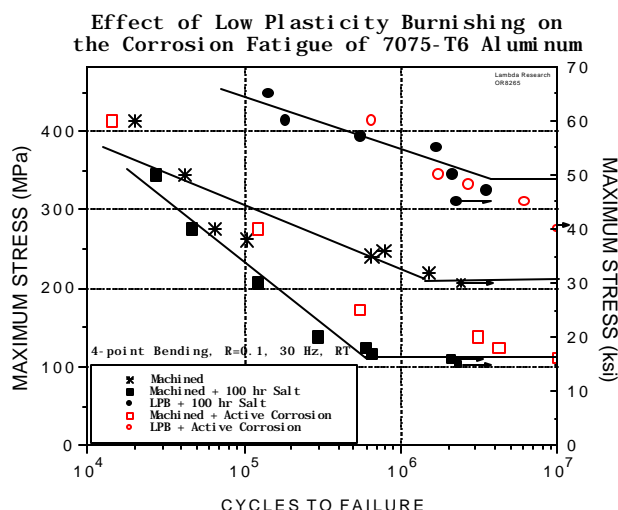
Figure 3 - High cycle fatigue results for salt fog pitted and active corrosion fatigue of machined 7075-T6 with and without LPB processing prior to exposure to corrosion.

The S/N curves generated for 7075-T6 in both the baseline (as-machined) and LPB conditions, after 100 hr salt fog exposure or active corrosion fatigue, are presented in Figure 3. Fatigue tests were continued for a minimum of 2.5×10^5 cycles with a maximum run-out at 1.2×10^7 cycles. The fatigue data are presented as semi-logarithmic S/N curves in terms of the maximum stress.

The S/N curves for samples with pitting from prior salt fog exposure appeared to exhibit an endurance limit, implying infinite life below some threshold stress level. As commonly observed in studies of corrosion fatigue, the S/N curves for samples exposed to active corrosion during fatigue testing do not appear to have an endurance limit.¹⁴ In the discussion that follows, the results are considered and compared in terms of the fatigue life at nominally 2×10^6 cycles.

The machined (end milled) surface condition produced an apparent endurance limit on the order of 200 MPa (30 ksi). Salt fog exposure for 100 hrs reduced the endurance limit to nominally 100 MPa

(15 ksi), half that of the original machined surface before exposure to salt fog generated pitting corrosion. Loss of nominally half the extended life fatigue strength following salt fog corrosion pitting appears to be typical of the degradation reported in the literature³. The fractional loss of fatigue life at stress levels above the endurance limit increased rapidly as the maximum stress level reduced, reaching an order of magnitude at the 200MPa (30ksi) endurance limit

Active corrosion fatigue in 3.5% NaCl solution, with no prior corrosion damage, degraded the fatigue strength relative to the as-machined condition by an amount only slightly less than prior pitting corrosion up to a life of 10^7 cycles. Note the failure occurring in active corrosion fatigue at the 10^7 cycle endurance limit for a maximum stress of 110 MPa (16 ksi). The data appear to suggest further reduction in fatigue strength with increasing life and the absence of an endurance limit for active corrosion fatigue of the machined 7075-T6 surface.

LPB prior to salt fog pitting resulted in a 70% increase in the endurance limit, from nominally 200 MPa (30 ksi) to over 330 MPa (48 ksi). LPB prior to corrosion pitting increased the fatigue life at stress levels above the base line endurance limit by two orders of magnitude, a 100X life increase over the un-corroded original machined surface.

A comparable benefit in fatigue performance was observed for LPB prior to active corrosion fatigue in 3.5% NaCl solution. As noted above, a true endurance limit may not exist for the active corrosion fatigue mechanism; however, the fatigue strength at 10^7 cycles was at least 282MPa (41ksi), 32% higher than the un-corroded original machined surface. Fatigue lives were 100 times that of the baseline for stress levels above the baseline endurance limit of 220 MPa (32 ksi).

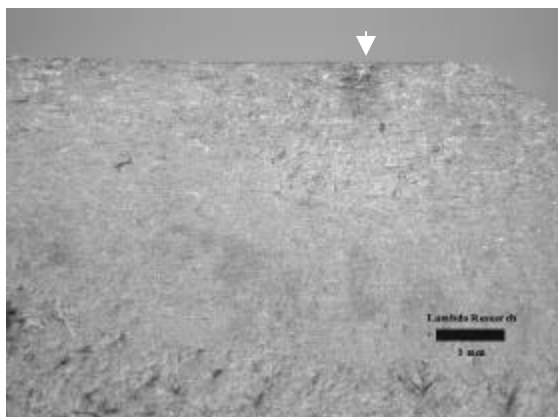
Figure 4 – Typical surface fatigue initiation site on machined 7075-T6 in active corrosion fatigue.

Fractographic analysis revealed that all the fatigue failures in specimens without prior LPB, whether exposed to salt fog pitting or active corrosion fatigue, initiated at the surface. A typical surface fatigue initiation site is shown in Figure 4. All of the salt fog pitted sample initiations were exclusively from corrosion pits, as observed previously⁶. Specimens tested at lower stresses generally exhibited origins from a single pit or surface location, while specimens tested at higher stress levels tended to have multiple nucleation sites.
